An **AEIS** Case Study

**Case Study:  
Failure Analysis of a  
Weld Neck Flange  
in a Refinery**

*By Nagesh Goel  
Technical Director*

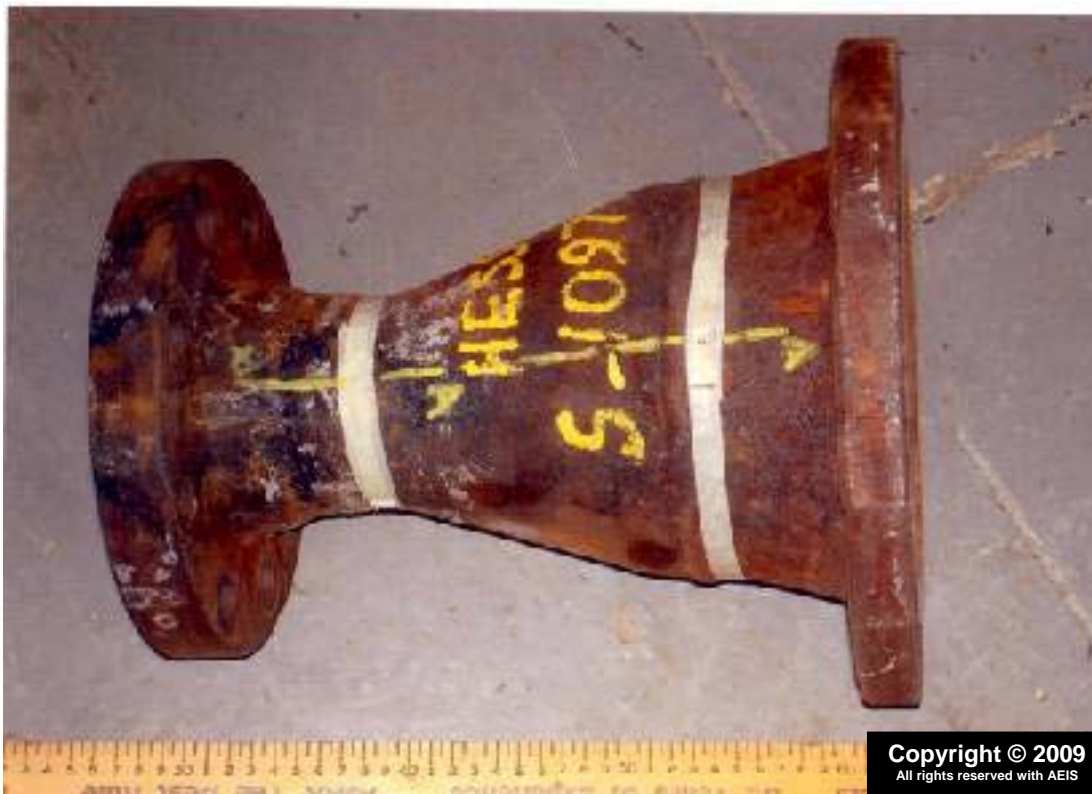
*A spool piece comprising of a three inch weld neck flange, a six inch by three inch eccentric reducer and a six inch weld neck flange, Figure 1, was submitted for failure analysis. The spool piece was installed on a Heavy Cut Naphtha line that operated at 380 Degrees F at 20 psig in a refinery. Naphtha leakage had been reported through this spool piece. The exact location of leak was not known.*

Figure 1: Spool Piece in "As Received" Condition

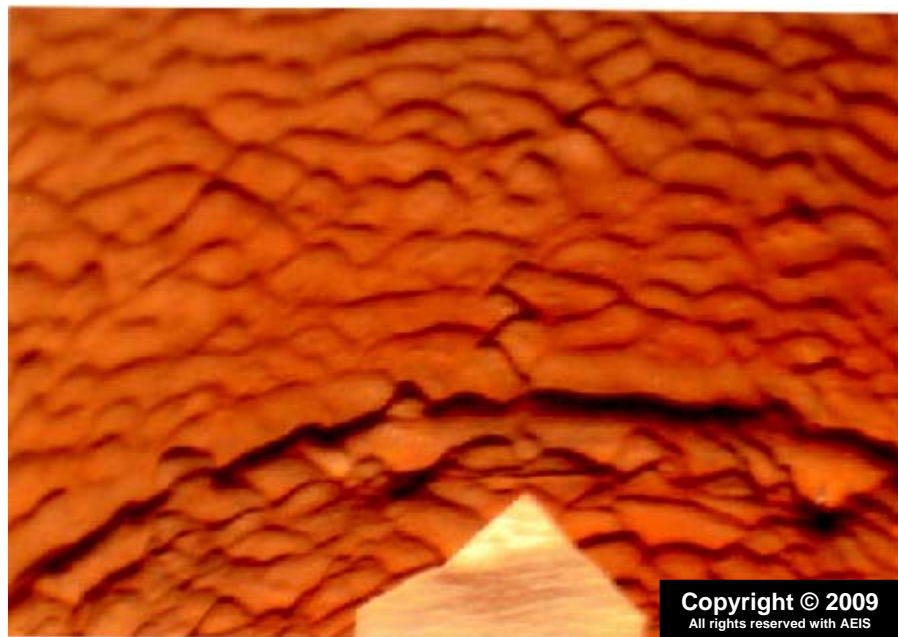
**Visual Examination of General Physical Area** The spool piece had the usual steel scale on the out side and a thin film of brownish rust on the inside. No appreciable deposits were observed on the inside surface. The inside surface of the six inch weld neck flange was free from any localized depressions. However the straight wall of the reducer and the 3 inch flange had smooth grooves (hills and dales) typical of erosion corrosion, generally aligned in direction of flow, Figure 2. The outside surface had tarry and dirty white cement like deposits in isolated areas. The weld bead had 1/8 inch high reinforcement. The root surface of the weld had eroded and no reinforcement could be seen. The inside surface showed a circumferential indication, shown with an arrow head in Figure 2, that looked like a possible crack through which the leakage occurred. This area was in the same region where the tarry deposit was observed on the outside surface and below the weld cap.

Figure 2: Internal Surface of the Spool Piece and the Suspected Crack

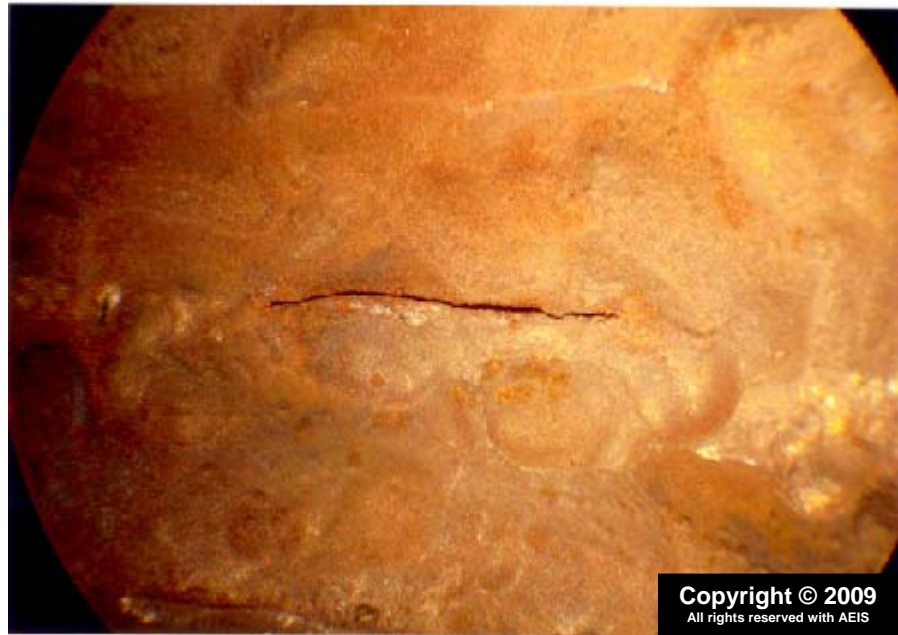
A rectangular section was cut around the above mentioned crack and examined under a low powered stereo microscope. The crack was located along the reducer side toe of the butt weld. The inside surface of the crack opening is shown in Figure 3. Two additional (smaller) crack like openings on the inside surface were observed within 1½ inch from the apparent end of the main crack. These indications had orange corrosion product spots at the lips and had similar orientation as the main crack. The longer of these cracks as observed on the inside surface is shown in Figure 4.

Figure 3: Crack Lips on the Inside Surface

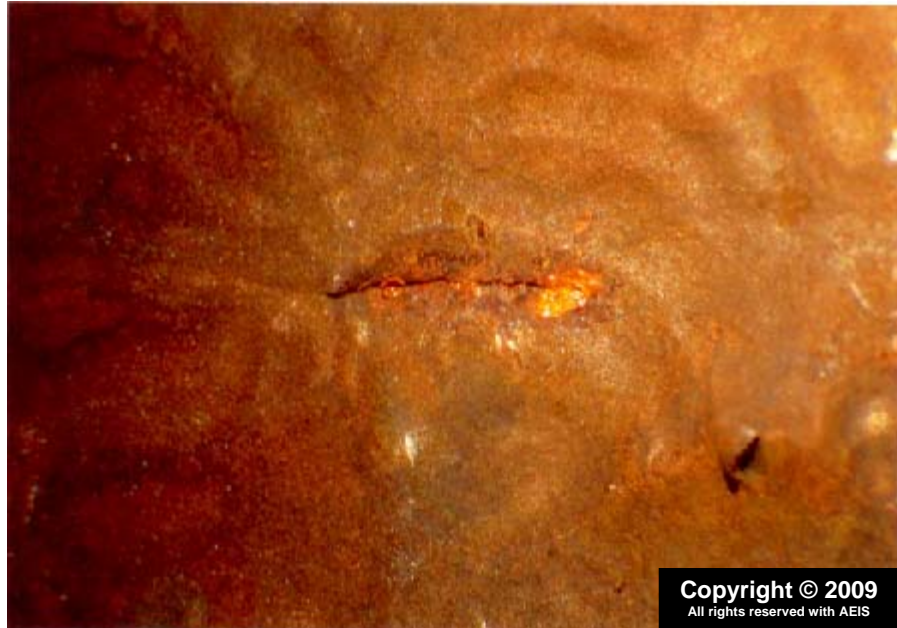
Figure 4: Another Crack Lip on the Inside Surface.

The acute dent at the outer surface was observed to be opposite to the second crack seen on the internal surface. This dent had abrasion marking on its side and metal flow at the lip suggesting that this was caused by a sharp tool such as chipping hammer used for slag removal. A similar dent was also observed opposite the third crack which was the smallest observed in the vicinity. The mechanical notches initiated these cracks.

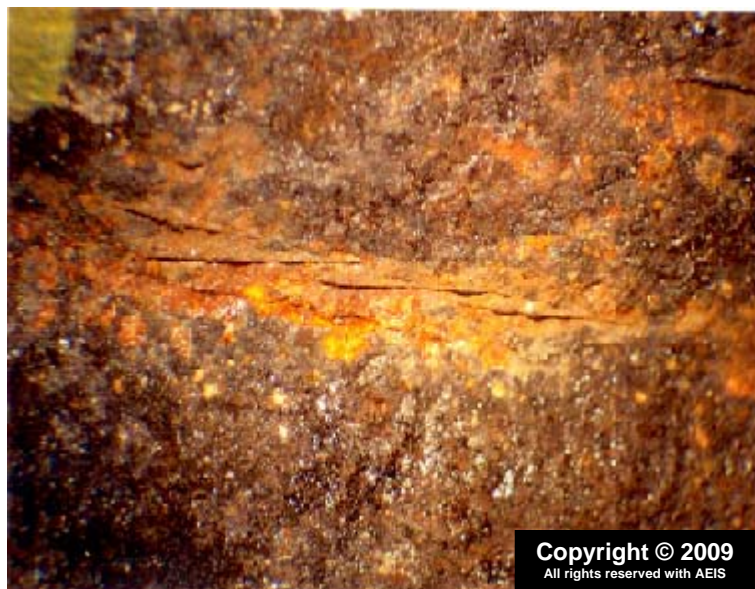
Some sharp mechanical dents on the outside surface were observed near the weld zone, Figure 5. The wedge shaped dents had abrasion lines on the side and displaced metal at the lip, Figure 6. It appeared that the crack like indications on the inside surface had corresponding dent marks on the inside.

Figure 5: Outside Surface Mechanical Dent Marks in the Weld Zone

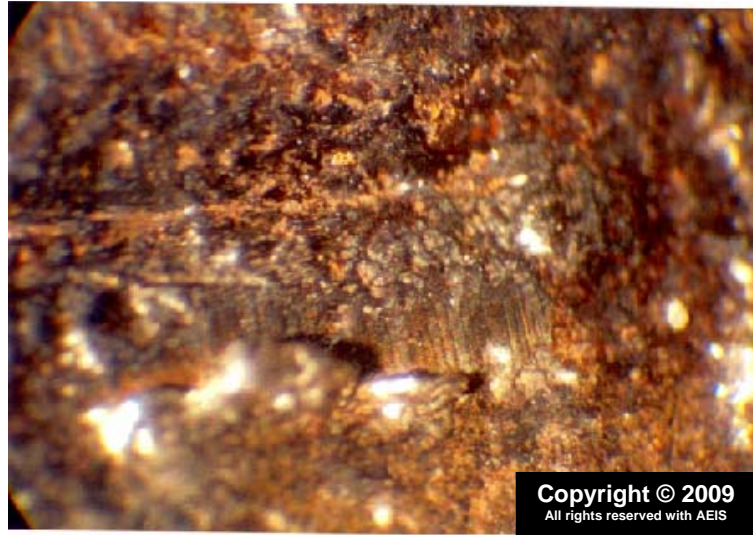
Figure 6: Abrasion Marks and Displaced Metal

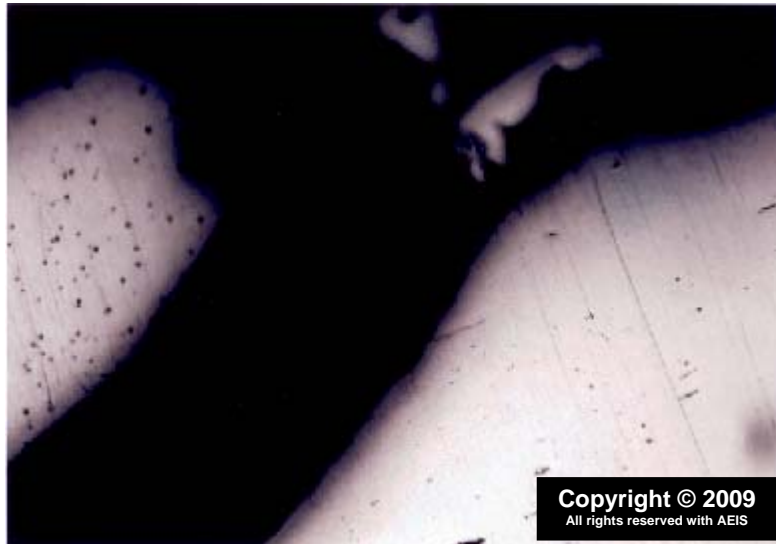
A section was cut through the confirmed crack and the cross section was prepared for microscopic examination. The unetched specimen showed that the flange side of the crack had elongated inclusions typical of forging. The weld side of the crack showed wide spherical non-metallic inclusions typical of a weld metal pool, Figure 7. The etched microstructure revealed the two sides of the crack as shown in Figure 8. Some slag was observed on the internal surface of the crack, near the outside opening of the crack, Figure 9, as well as near the inside opening of the crack, Figure 10. The variance in microstructure at 100X magnification is shown Figures 11 through 16. Figure 11 shows the microstructure of the reducer parent metal. Figure 12 shows the microstructure of the heat affected zone (HAZ) of the reducer. The microstructure of the weld metal pool is shown in Figure 13. Figure 14 shows the weld metal pool to the weld neck flange (WNF) interface. Figure 15 shows the heat affected zone of the WNF and the Figure 16 shows the microstructure of the WNF flange parent material. Internal cracks were observed. Inclusions such as mentioned earlier in and as seen in Figure 14 were observed.

Figure 7: Both Sides of the Crack before Etching 250X Magnification

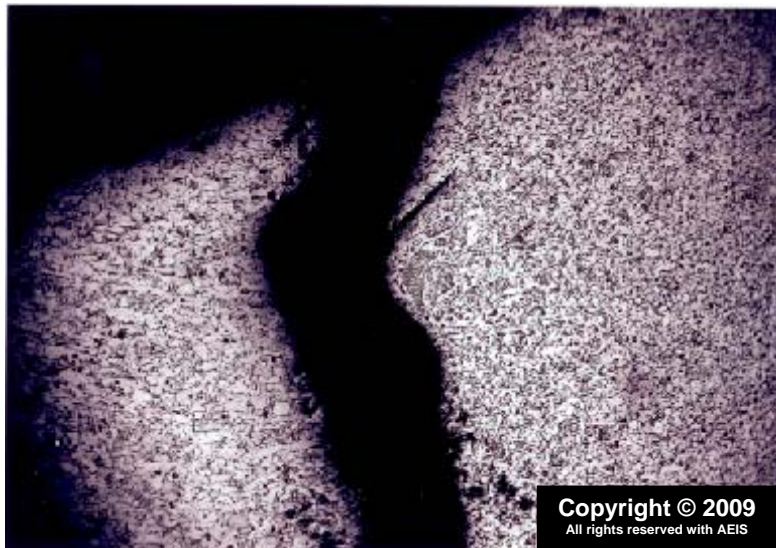
Figure 8: Both Sides of the Crack after Etching 250X Magnification

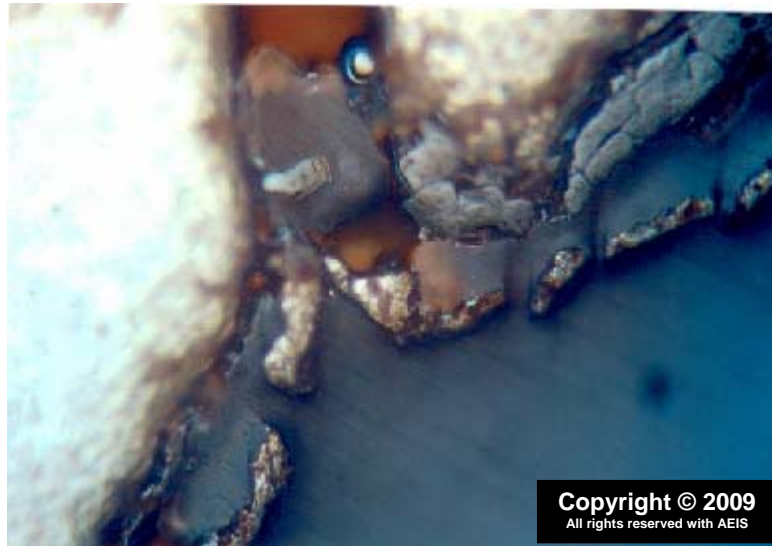
Figure 9: Slag on the Internal Surface of the Crack near the Outside Surface

The stresses concentration is inherently high at the weld toes. Cracking will initiate at the edge in absence of any other weakness. The larger crack, in this case, had an additional deficiency. Microscopic examination showed the presence of slag inside the crack, implying that there was a lack of fusion and or undercut in the weld. Gradual gouging of metal from inside continued till the wall thickness at the weakness gave way. Another weld weakness can be observed in Figure 14.

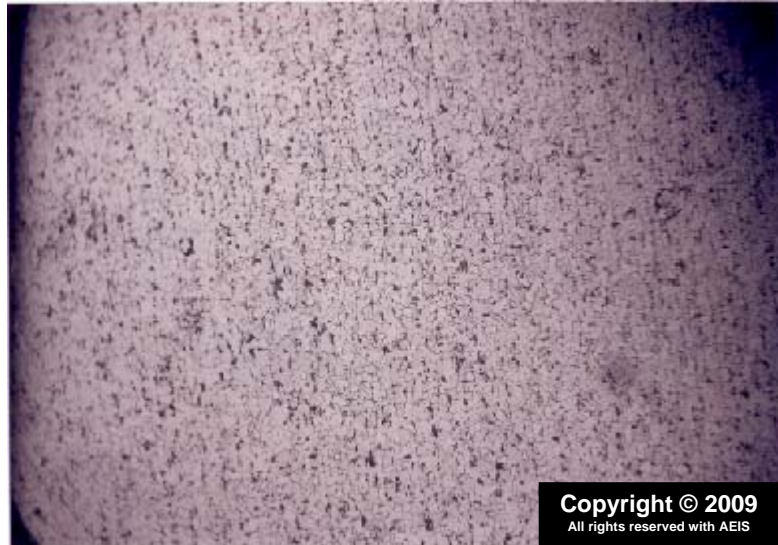
Figure 11: Microstructure of the Reducer Parent Metal 100x Magnification

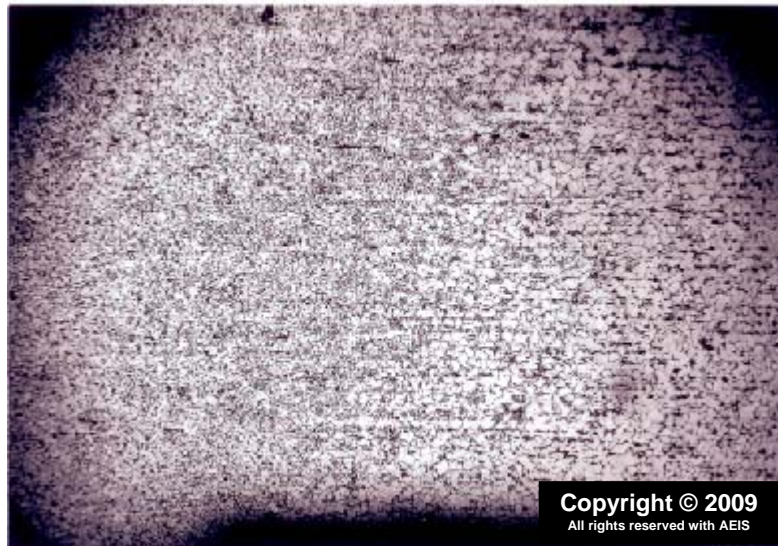
Figure 12: Microstructure of the Heat Affected Zone of the Reducer 100X Magnification.

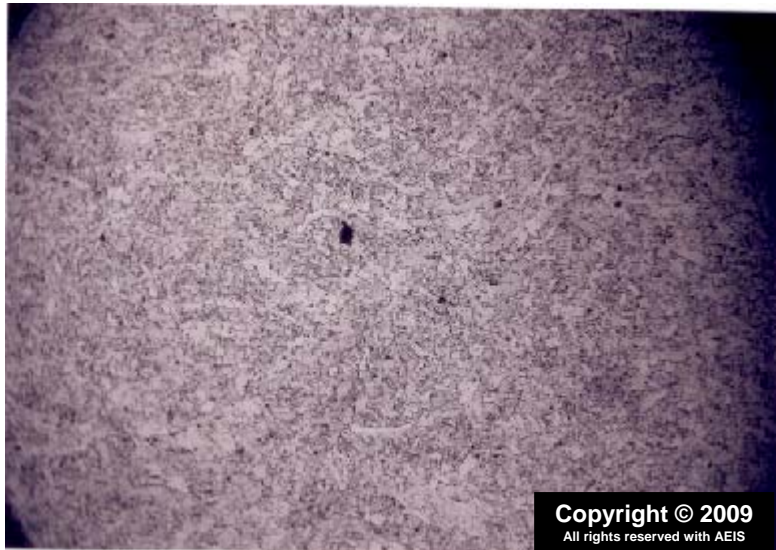
Figure 13: Microstructure of the Weld Metal Pool 100X Magnification

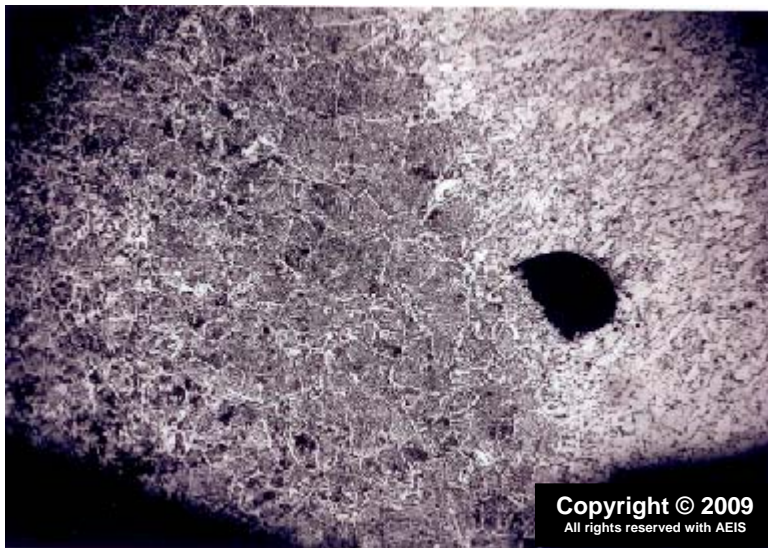
Figure 14: Weld Metal Pool to Weld Neck Flange Interface  
100X Magnification

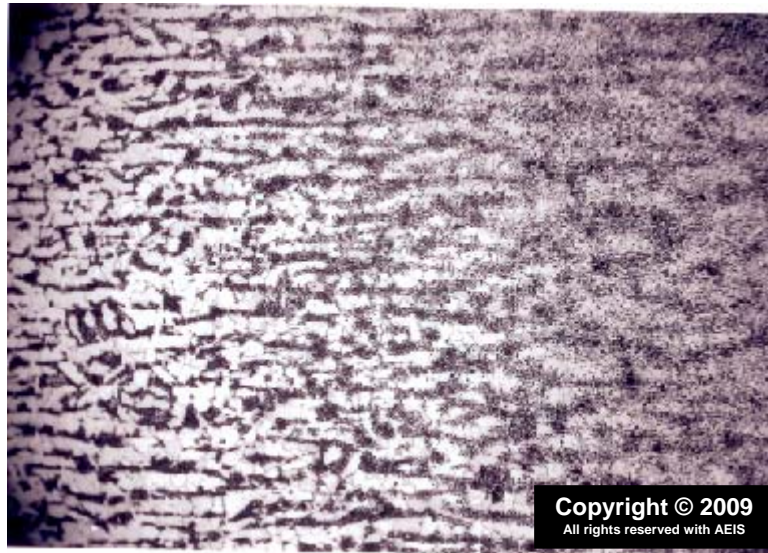
Figure 15: Heat Affected Zone of the Weld Neck Flange  
100X Magnification

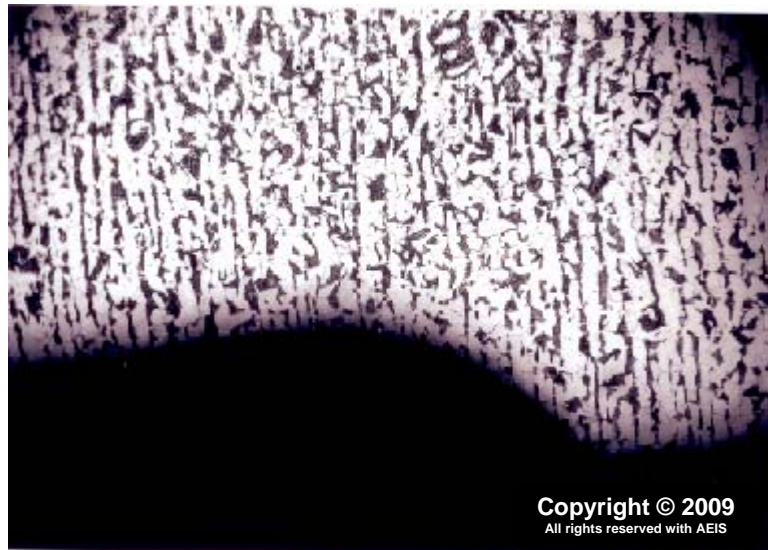
Figure 16: Microstructure of the Weld Neck Flange Parent Material  
100X Magnification
